Special Report 84-12

May 1984

Deteriorated concrete panels on buildings at Sondrestrom, Greenland

Charles Korhonen

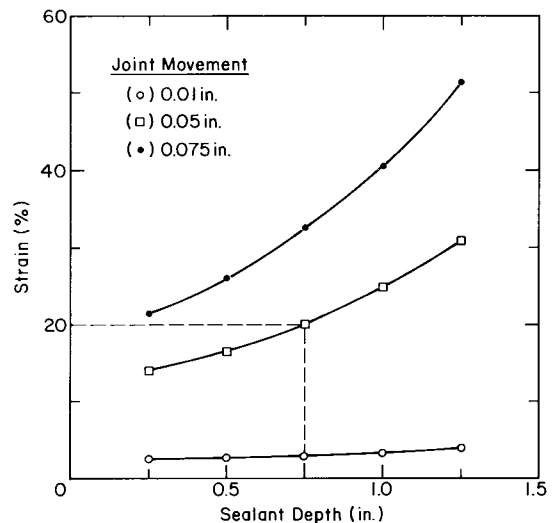
they will return to their original shape even in very cold weather. To be effective, the sealant should not completely fill the joint. There is a definite correlation between sealant depth and joint width (Fig. 10). As an elastic material is stretched, it begins to thin, producing the greatest strain at the top and bottom surfaces. For the elastomeric sealants mentioned above, the allowable working strain is $\pm 25\%$ (Maslow 1974). As shown in Figure 10, a 3/8-in. joint subjected to a 0.05-in. movement produces a 25% strain in a 1-in.-thick bead of sealant. However, to avoid even approaching this strain, the sealant should not be placed any deeper than 3/4 in. A polyethylene-foam backer rod should first be inserted to the proper depth in the joint, both to create the desired sealant cross section and to prevent the sealant from sticking on its bottom side.

Figure 10. Relationship between movement, sealant strain and sealant depth for a 3/8-in.-wide joint. (After American Concrete Institute 1983b.)

Before any cosmetic repairs are made, all cement mortar between panels must be removed to avoid further stress cracking. If a sealant must still be used in those joints, an elastomeric material would be best. Polysulfides, polyurethanes and silicones are excellent choices for working joints because
